Operating Experience Weekly Summary 97-47

November 14 through November 20, 1997

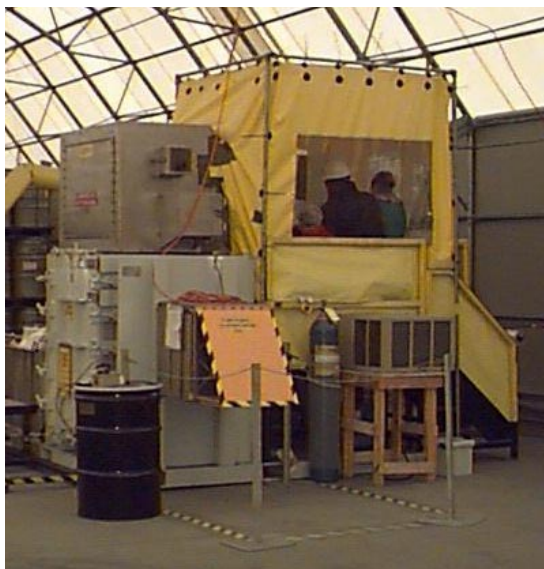
On November 10, 1997, at the Savannah River Site, operations personnel determined that the process currently used to vent transuranic waste drums may not ensure that hydrogen and oxygen concentrations do not exceed the lower flammability limit. In August, operations personnel vented, purged, and sampled drums packaged before 1988. These drums had not been vented previously. During this operation, they determined that hydrogen and oxygen concentrations in three drums exceeded the lower flammability limit. Operations personnel installed vents and re-sampled the drums; however, the hydrogen and oxygen concentration in two of the three drums still exceeded the lower flammability limit. The facility manager suspended vent and purge operations until a response plan is implemented and corrective actions are completed. Exceeding the lower flammability limit indicates that there is a potentially explosive mixture of gases in the drums. Ignition could result in an explosion that leads to the release of hazardous materials; the contamination of personnel, equipment, and facilities; and the potential for fires and injuries to personnel. (ORPS Report SR--WSRC-SLDHZD-1997-0019)

Investigators determined that the drums contained plutonium waste sealed in plastic bags. Nuclear Filter Technology, Incorporated, designed and manufactured the vent (model FT072), as well as the vent and purge machine used in the facility. Figure 1-1 shows the vent and purge machine.

Figure 1-1. Vent and Purge Machine

- Re-vent the drums and determine how long it takes for the hydrogen concentration to remain below the lower flammability limit.
- Determine the diffusion rate for hydrogen, oxygen, and nitrogen through the vent and purge machine filter vent and through the drum vents.
- Determine if experiments on the drums are needed, evaluate any experimental data, and revise operating procedures if necessary.
- Document the applicability of technical safety requirements to legacy waste.

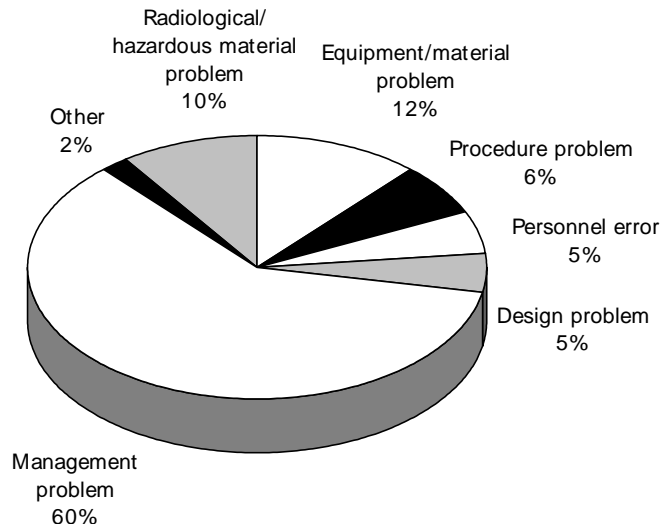
OEAF engineers searched the complete ORPS database for events reported across the DOE complex involving excavation and the spread of contamination and found 65 occurrence reports. Figure 3-1 shows that facility managers reported management problems as the root cause for 60 percent of the occurrences. Further review shows that 54 percent of the management problems were reported as inadequate administrative control.

Figure 3-1. Distribution of Root Causes for Excavation and Spread of Contamination Events¹
